Arch 5672 Historic Building Conservation  
Assignment 7: Final Recommendations and semi-final documentation  
R.R.S. Stewart (member of Group 5)  
14/21 April, 2005

Knox's Presbyterian Church  
1536 West Minnehaha Avenue  
St. Paul, Ramsey County, Minnesota

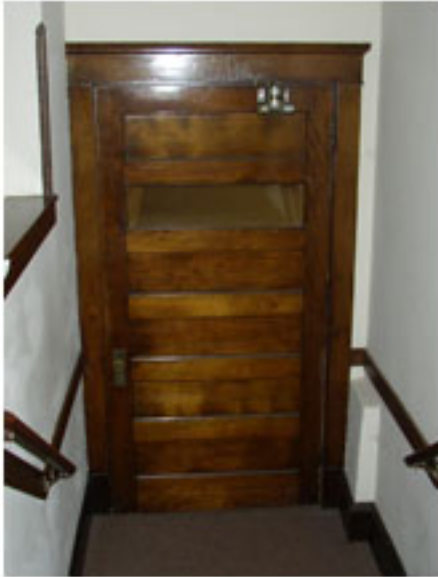
Left: Opening 17, which still has old handle and hinge

I also recommend trying to replicate the original hinges. Opening 17 (pictured) and opening 18 are the only doors we've found that still retain their original hinge, but the ghost of the above door hinges can be found on the rest of the doors (see detail of 10). The hinges of Openings 17 and 18 (detail) could be used to replicate hinges for the others. Most of the doors still have their old handles, but they need to be cleaned. Opening 10 is not equipped with its original handle; instead it has a piece of new anodized brass hardware (see detail). After these handles have been removed, appropriate pieces could be replicated from Opening 17 (see detail).

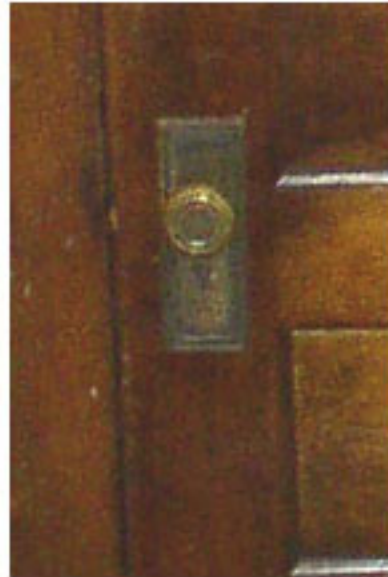
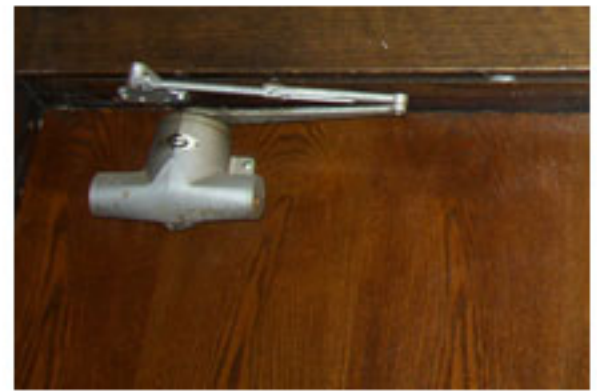
Middle and right: close up of old handle and hinge that we want to replicate

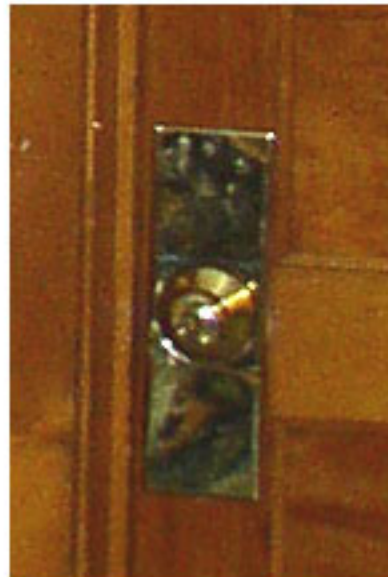
Middle and Right: close up on new handle, which want to replace, and the hinge ghost, showing where 10 used to have a hinge like 17

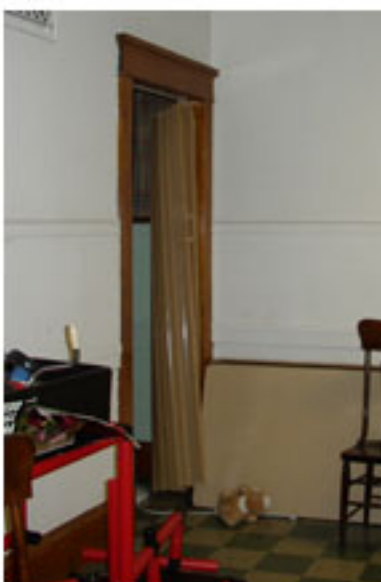
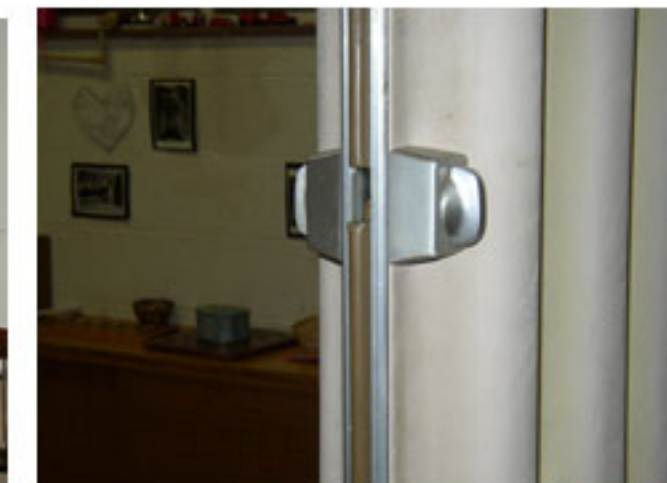
The screen in opening 8 was probably installed around the same time as the addition to Knox. There are two different models of partition, differentiated by their door handles (see details). Most of the screen have been folded for so long that they only retain their original color in the folds, but have faded otherwise. As it appears that most of these dividers aren't used (and haven't been for a long time) we recommend removing most of them. The ones that are retained should be repaired as much as possible. If any need to be replaced, Home Depot or Lowe's might be able to order new doors from Panelfold®, the company that made the originals.

Middle and Right (below): Close ups of the two types of handles on the dividers in the new addition; this dividers are similar to the one in opening 8

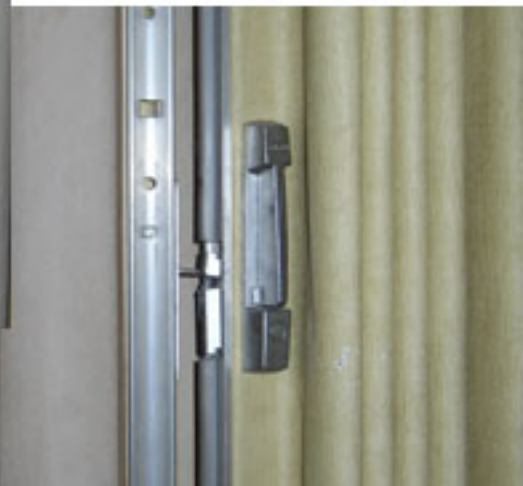
In Opening 8 (see photograph), the original door has been removed and a collapsible screen has been installed in its place. I do recommend reversing this change, as the Pella model folding screen is in pretty bad shape. If there are any old doors in storage in the church, one might fit this opening, otherwise, a new door should be made or ordered. The other option is to leave the closet without a door, which would be fine considering it essentially has none right now. If a new door is found or made, it will have to be refinished to match the others. In either case, I recommend installing shelves or other storage units in this area behind opening 8 in order to meet the building's present day requirements (and so things can be stored in a way other than piling it on the floor).

Left below: opening 8, where door has been replaced with a divider
